Service

Category Audio/Visual/Telematics

Section Cellular Communication Market USA

# **DCM Reset and Firmware Update (LG)**

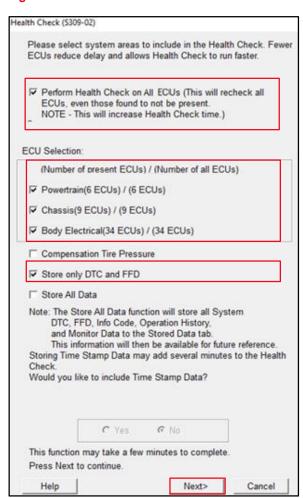
### Figure 1.

- Move the vehicle to an area with good DCM (Data Communication Module) signal reception.
- 2. Using Techstream, perform a Health Check and clear ALL DTCs.
  - A. Check the "Perform Health Check on all ECUs" box.
  - B. Check the "Store only DTC and FFD" box.
  - C. Click on Next.

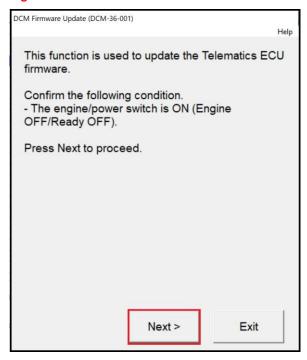
Figure 3.

9. Click on Next when the DCM firmware update screen appears.

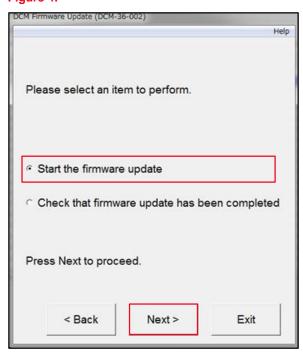
Figure 4.

10. Select "Start the firmware update" and click on Next when the item selection screen appears.

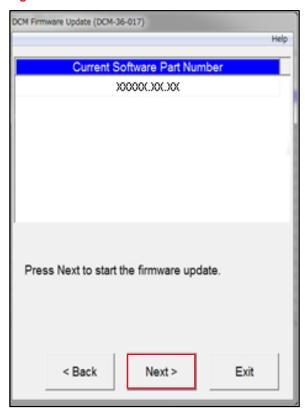
Figure 5.

Click on Next when the current software part number screen appears.

If the screen in Figure 5 does NOT appear and an error message displays, begin the Firmware Update Procedure again from step 4. The battery reset MUST be performed again.

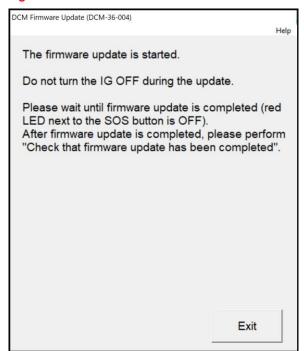
Figure 6.

- Do NOT press Exit until the update process has completed.
- During the update process the green and red LEDs will both be ON, and will reset several times resulting in the LEDs being temporarily OFF during the process. The download process will take about 5 – 10 minutes.
